Lowe's of Temecula

Temecula, California, USA

Keller installs soil nails to remediate a failing retaining wall protecting a popular home improvement store.

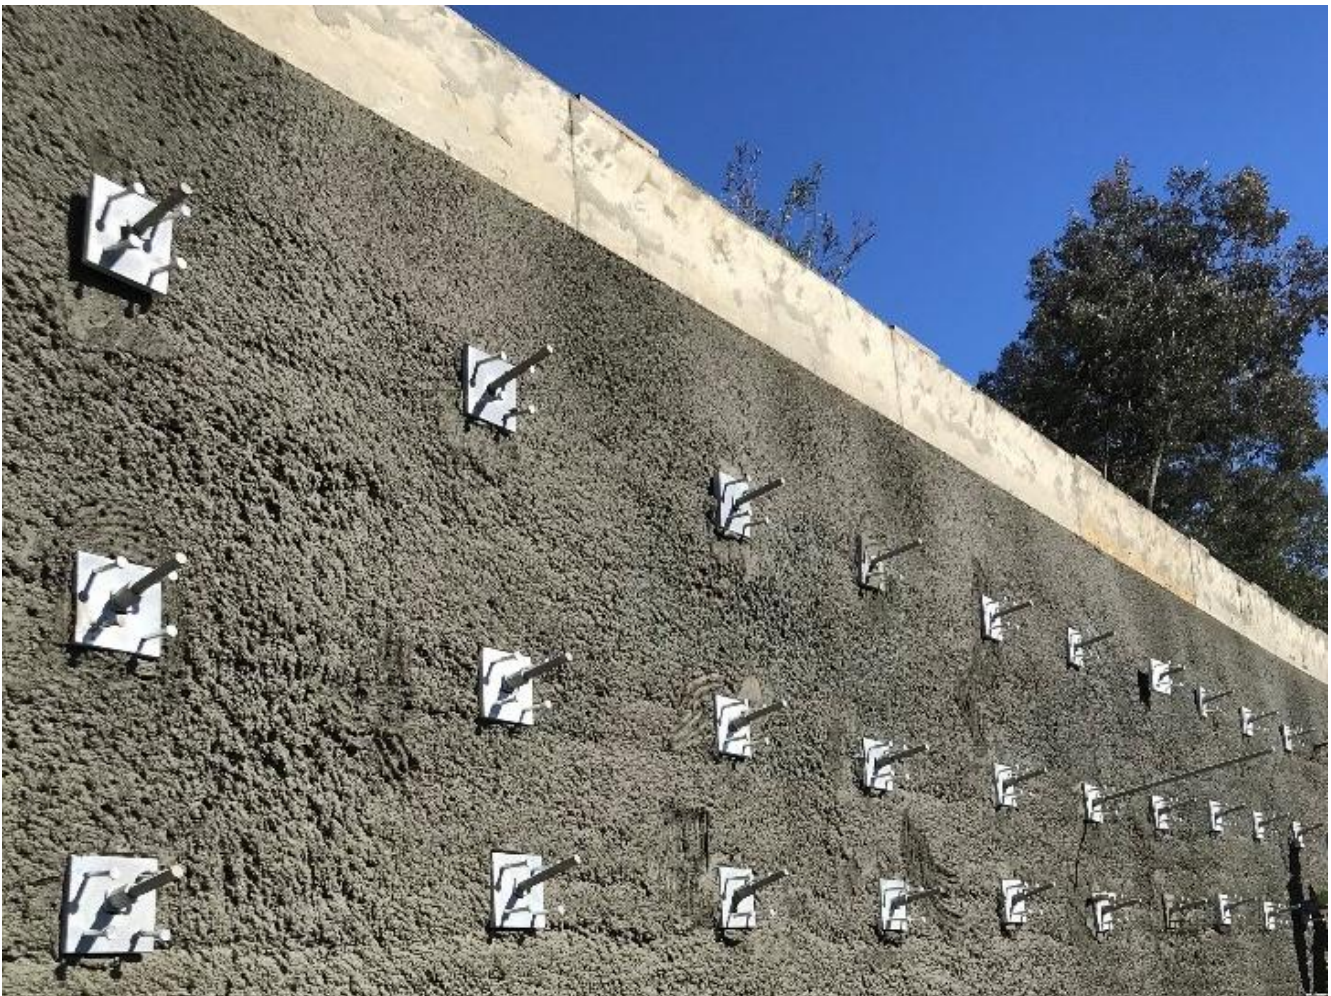
Located behind a Lowe's Home Improvement store, a 15-ft-tall retaining wall began showing signs of deterioration. The 8600 SF wall was originally constructed using soldier piles, precast concrete lagging, and reinforced with tieback anchors. The retained slope consisted of loose caving soils with manufactured backfill. Prompt remediation was needed to prevent the full failure of the wall.

Keller was contracted to install soil nails to stabilize the existing wall. Keller installed two rows of soil nails, 500 nails total, with an average length of 34 ft. The quality control program included installing two sacrificial soil nails that were tested to verify the design assumptions and installation procedures. Because of the cooperative effort between Keller and the general contractor, the home improvement store remained open throughout the construction, and the customer experience was not impacted.
